1 Example Street, Exampleville,  
Exampleshire, England, EG1 1EG

| <b>TENANT NAME</b><br>Peter Parker | <b>TENANCY TYPE</b><br>Single |

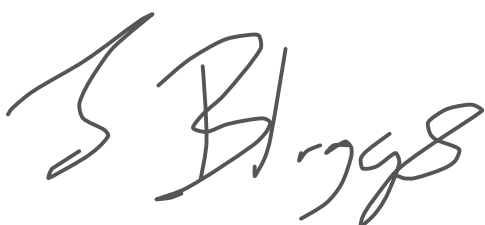
**Name:** Joe Bloggs  
**Date:** 13/11/2024 at 9:55am
